Technical Review Site Inspection Report

Regional Groundwater Contamination
(Alleged St. Louis Park Solvent Plume)
St. Louis Park, Minnesota

ST. LOUIS PARK SOLVENT PLUME
ST. LOUIS PARK, MINNESOTA
SITE INSPECTION REPORT FOLLOW-UP INFORMATION

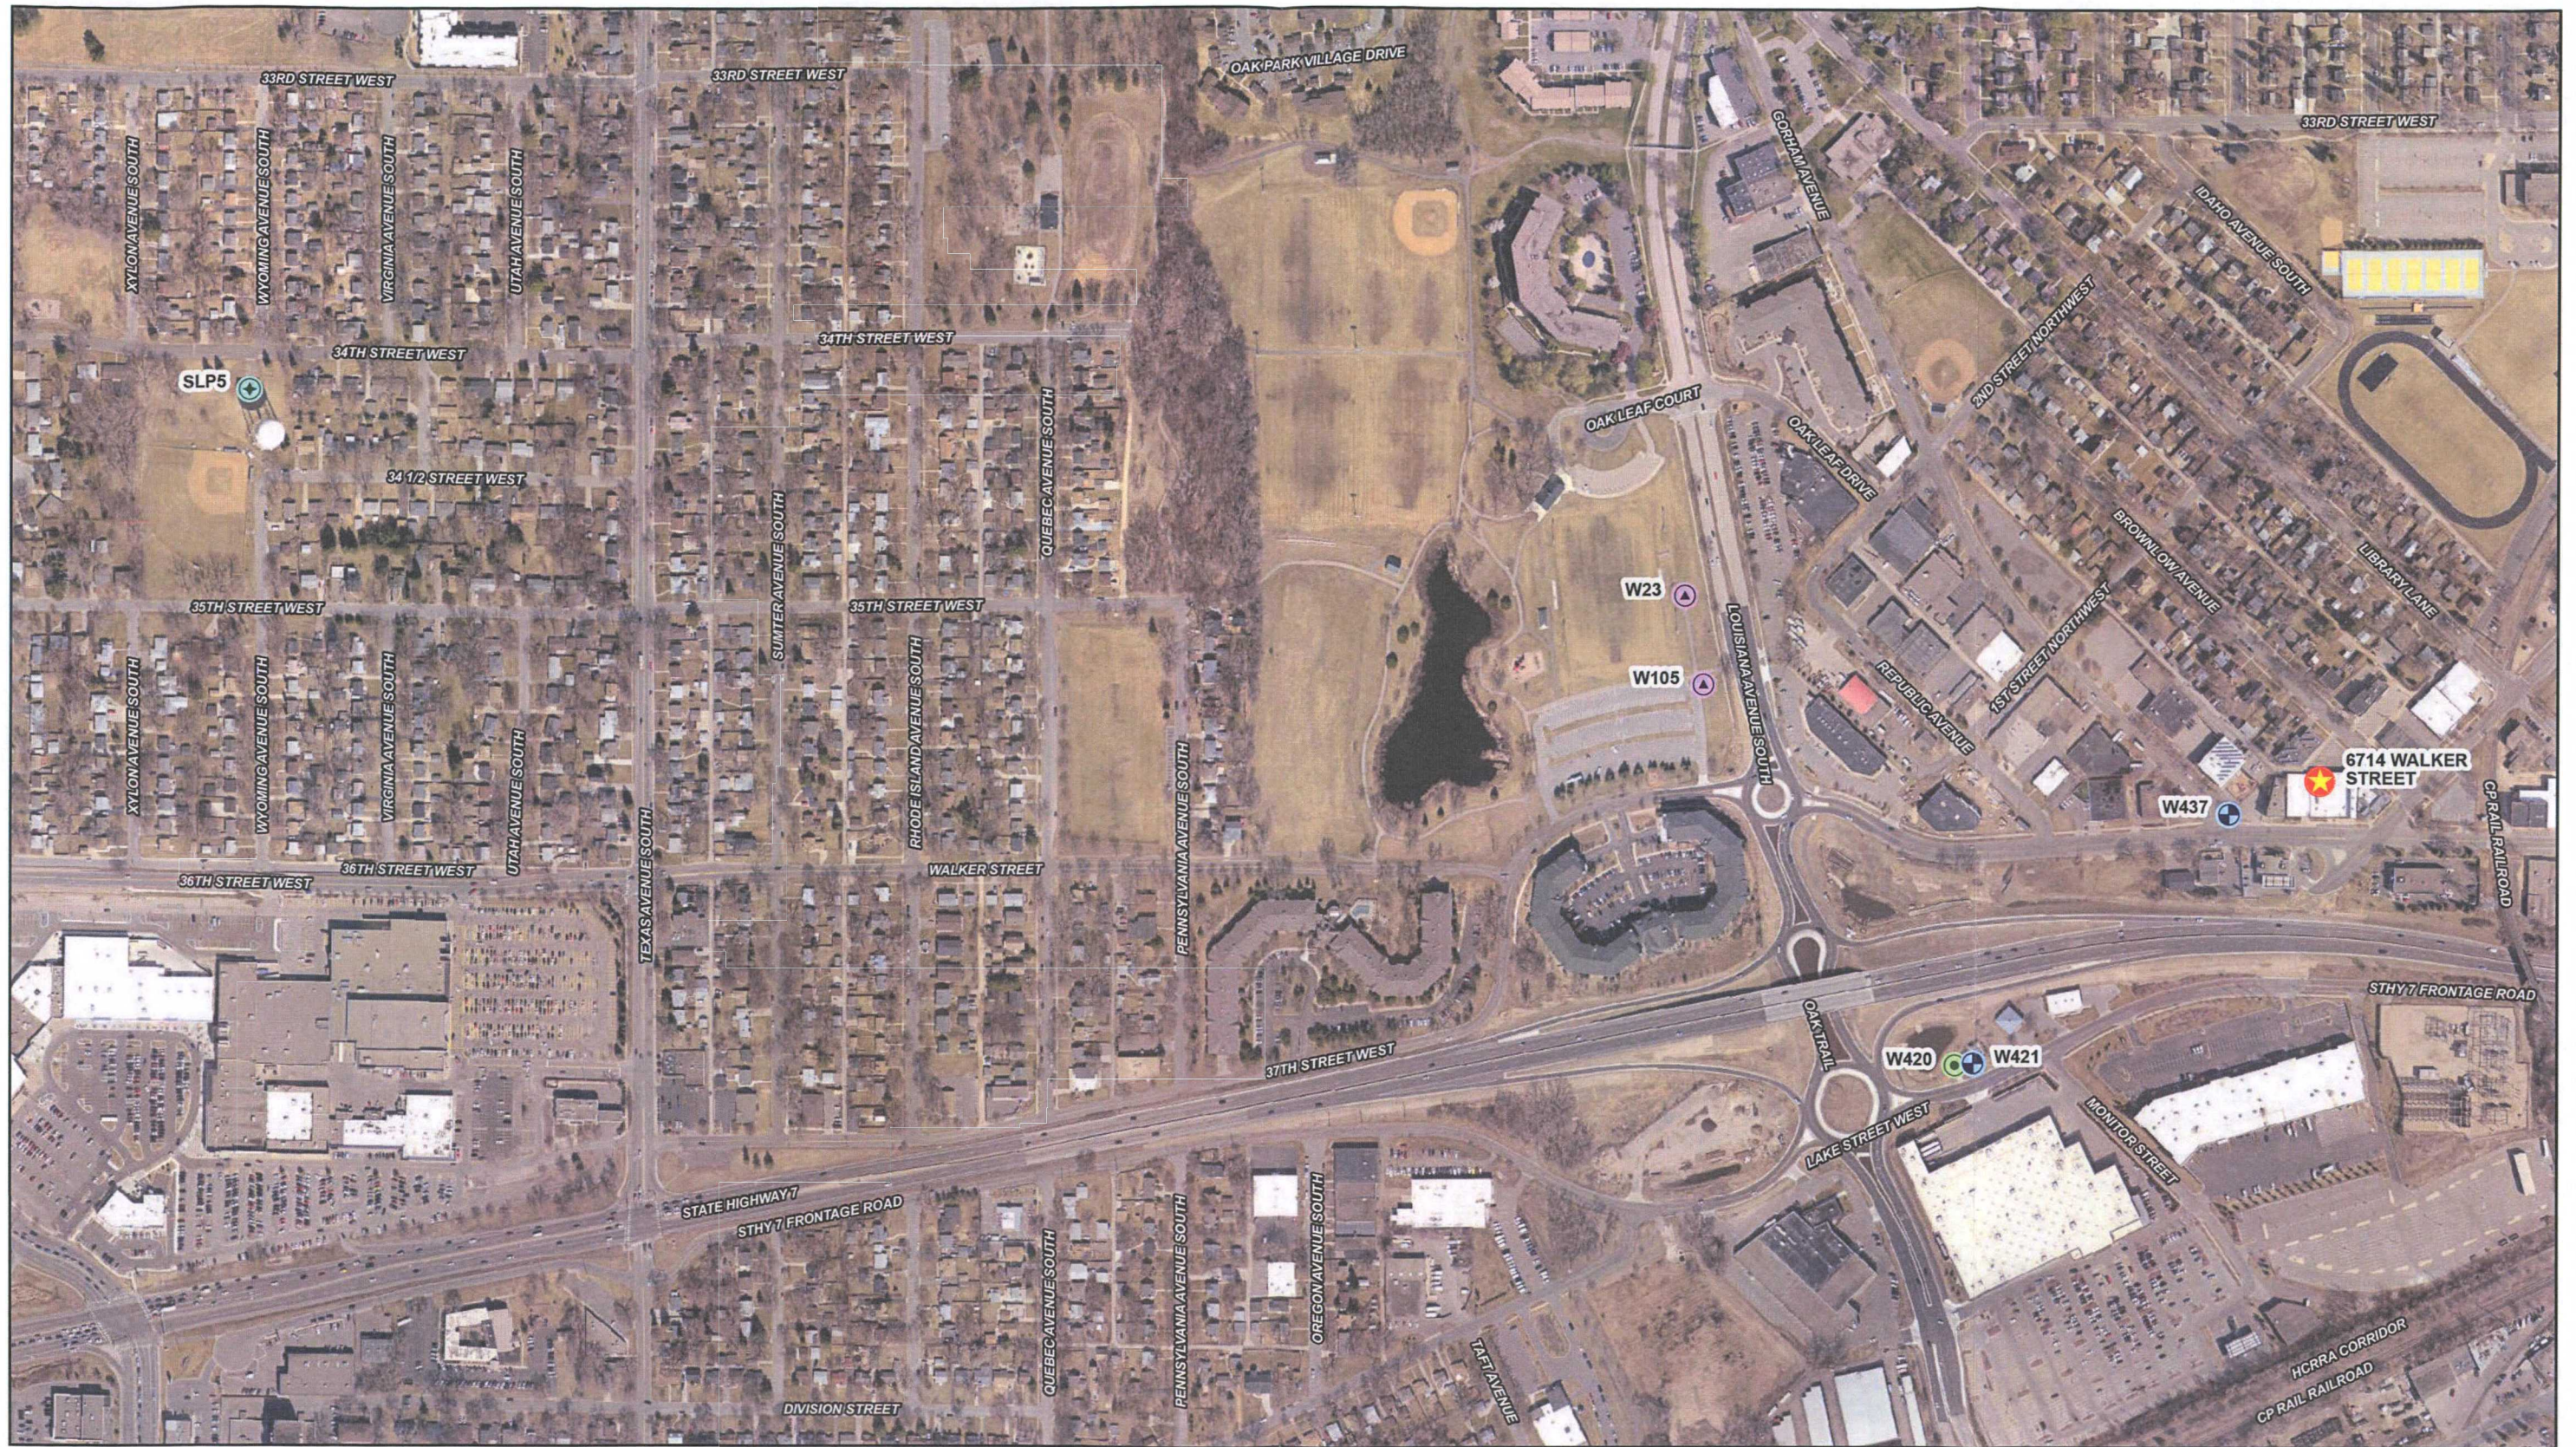
FIGURE 1

- The SIR fails to deal with indications from the data (STS, 2005.⁶) of the significance of multi-aquifer wells, which provide vertical conduits between aquifers such as W-23 and W-105 on the Reilly Tar site (see Figure 1), and others.

CVOCs are present in deep aquifer wells located more than one-quarter mile upgradient of 6714 Walker Street. Figure 1 identifies these deep impacted wells. Two wells located on the former Reilly Tar property (W-23 and W-105) have repeatedly tested positive for CVOCs in their groundwater samples. As reported in Section 3.2.1 of our March 2017 Technical Assessment Report on the PAR, W-23 and W-105 cross connect multiple aquifers, including the aquifers used by the SLP and Edina municipal wells. These Reilly Tar wells are likely conduits for cross contamination flow between the different aquifers and direct conduits to the regional Prairie du Chien/Jordan municipal aquifer system.

The SIR included sampling results of several municipal wells in SLP and Edina. SLP5 was sampled as a "background" municipal well. (see Figure 1). SLP5 is located one mile WNW of 6714 Walker Street and is an inactive (non-pumping) municipal well. SLP5 is screened in the Prairie du Chien-Jordan aquifer. The SLP5 sample contained two CVOCs, *cis-* and *trans*-1,2-dichloroethene. The presence of CVOCs at this inactive well indicates that CVOC sources that have no possible connection to past operations at 6714 Walker are present in the aquifers used by municipalities throughout a large regional area. The SIR, like the PAR before it, however, ignores this key piece of information. This failure constitutes another deficiency that demonstrates the lack of evidential support for MPCA's allegations and conclusions that the alleged St. Louis Park Solvent Plume exists or is sourced as MPCA alleges.

The Reilly Tar groundwater treatment plant is located south of Highway 7 and east of Louisiana Boulevard, approximately 1,000 feet WSW of 6714 Walker Street. Figure 1 shows the location of the treatment plant. Two nearby wells, W420 and W421, were installed in the late 1980s as source control wells to contain contamination emanating from the Reilly Tar site. W420 and W421 pump from the glacial drift and underlying Platteville Limestone, respectively.

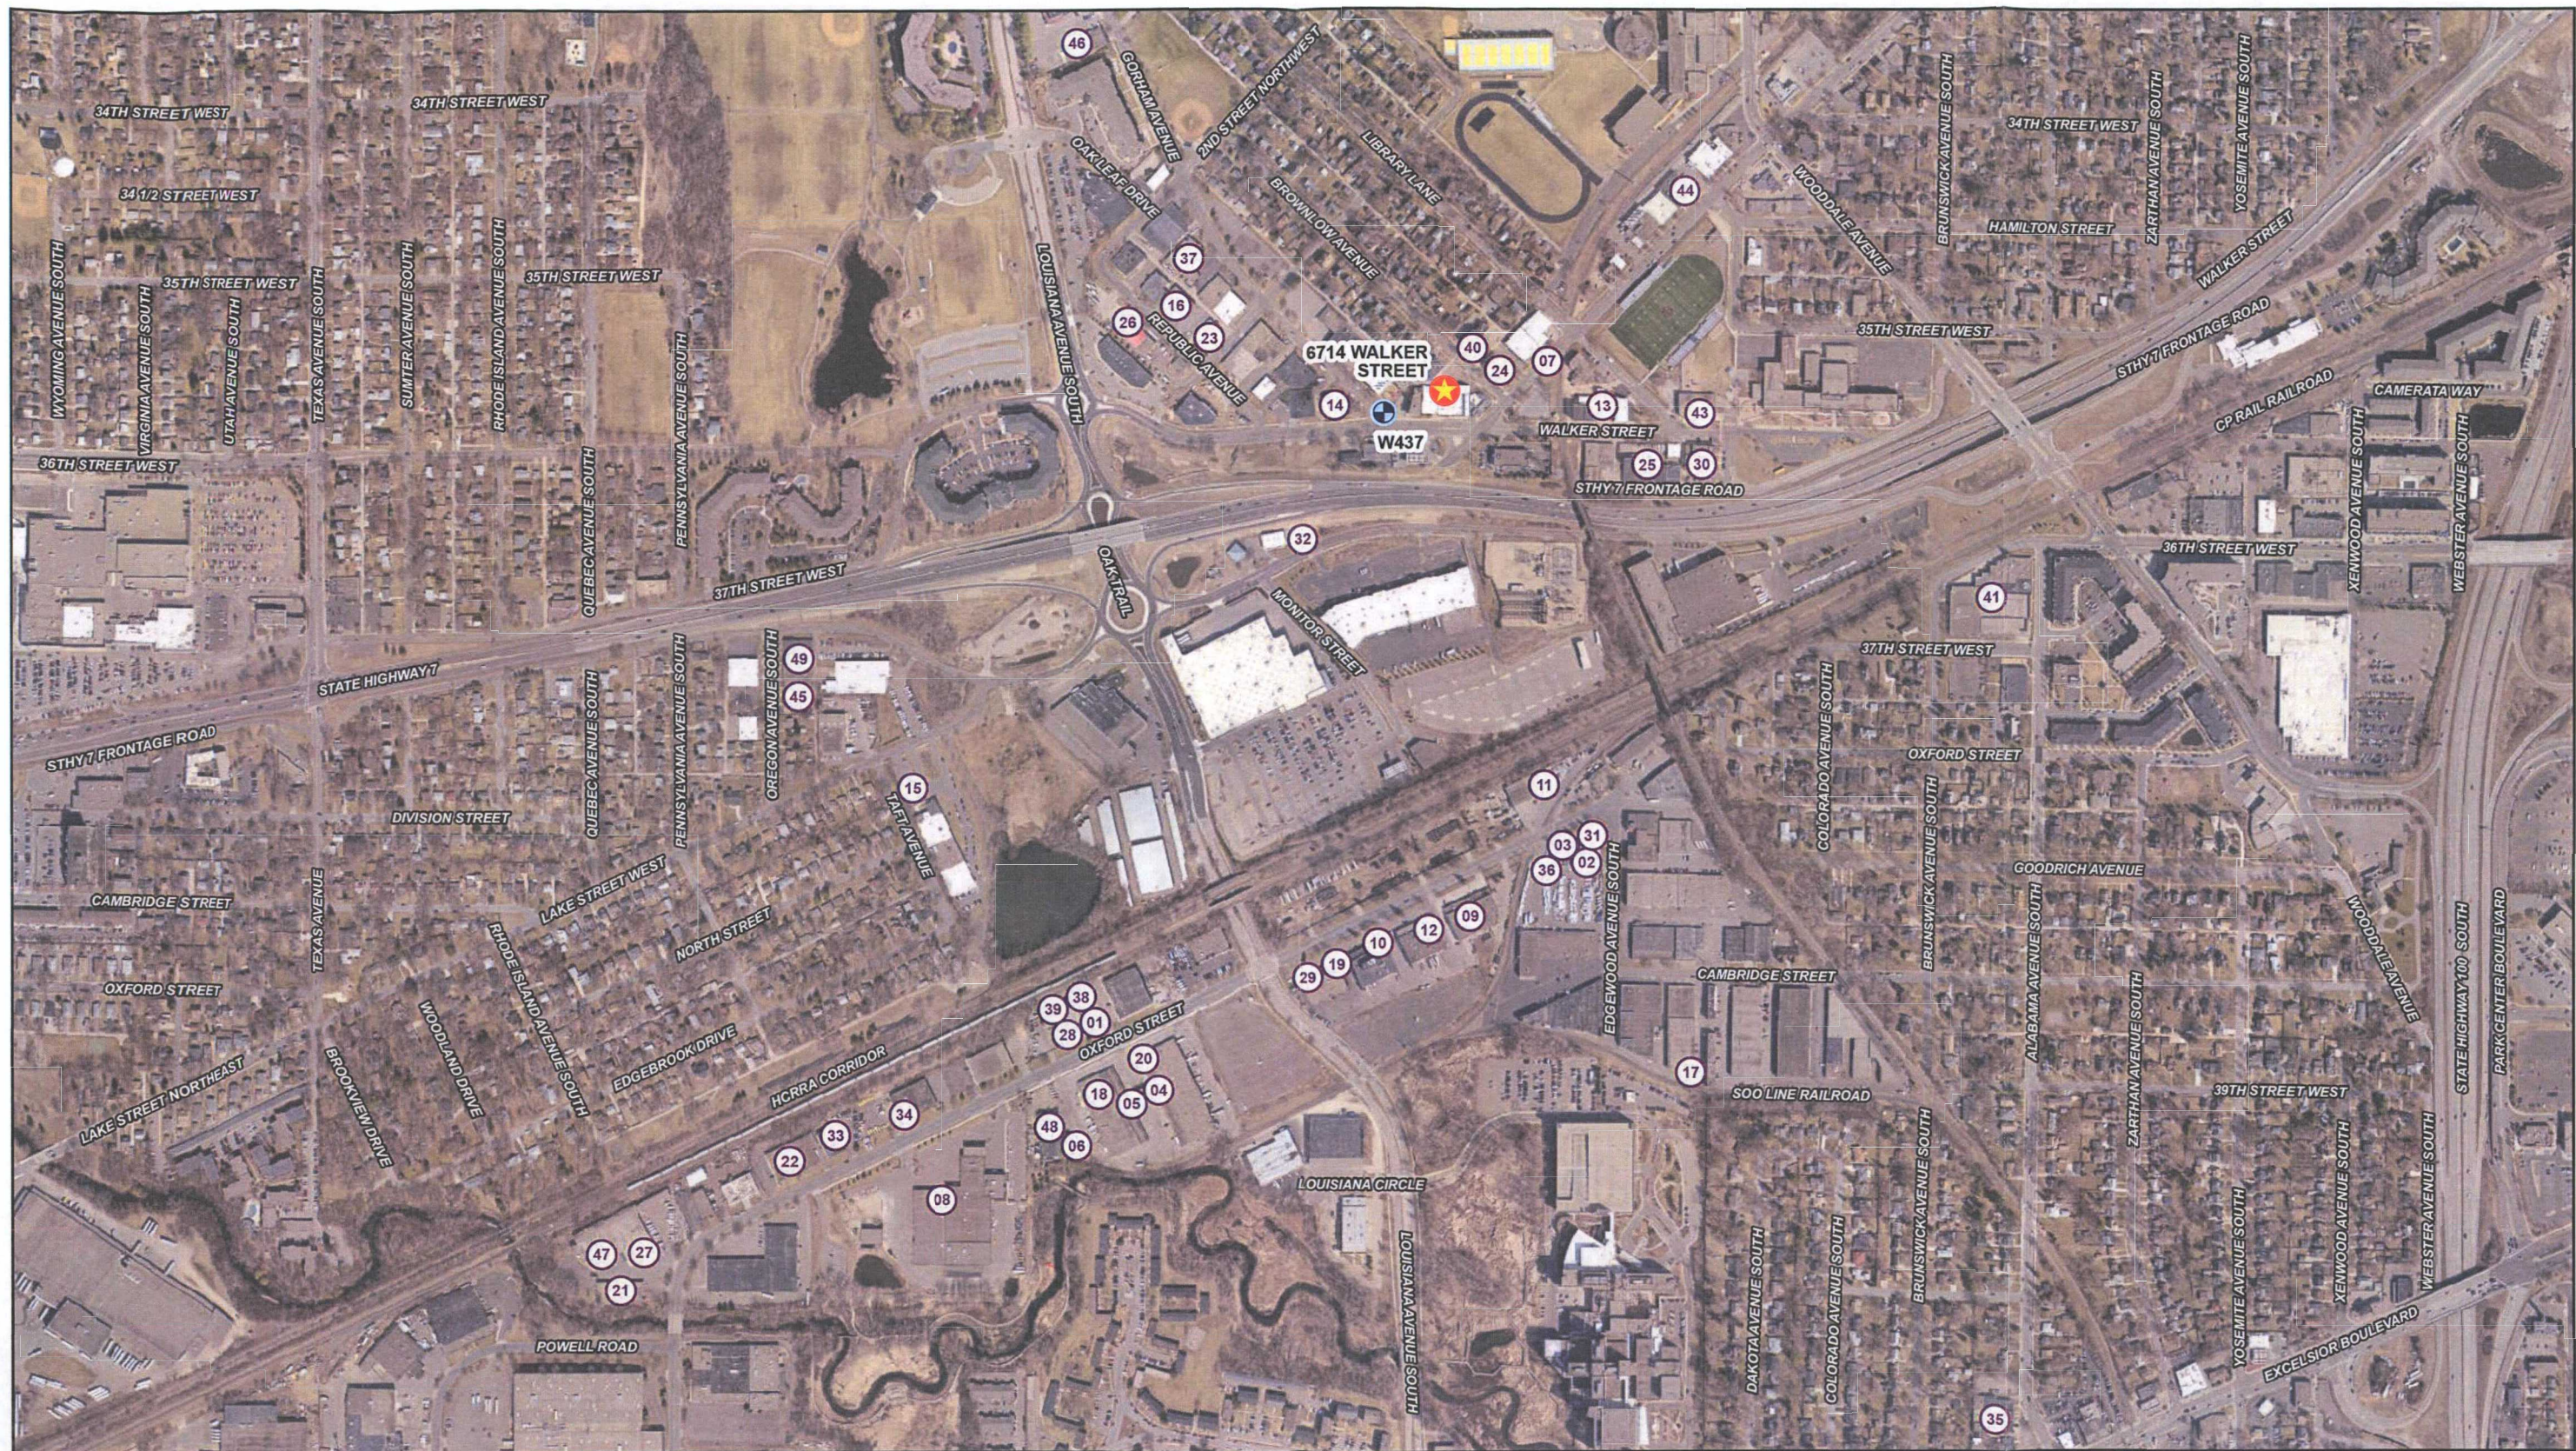
FIGURE 2

The MPCA thereafter authorized the STS 2006 investigation in the Walker Street and Lake Street area of potential CVOC sources near W437. Inexplicably, the 2006 investigation did not include the Reilly Tar site, which had reported CVOCs in its onsite well (W23) dating back to 2004. In 2006, STS reviewed the Hennepin County Hazardous Waste Generators for records of waste generation dating back to the 1980s. From this database review, STS identified 82 sites and listed 49 sites in the area of W437 that used or appeared to have used CVOCs. Figure 2 shows the locations of these 49 sites. Under this investigation, STS collected no physical data (e.g., soil samples) from these sites to determine if they were a CVOC source.

In 2009, AECOM¹⁰ investigated 12 sites in the 6714 Walker Street area for the MPCA. The 12 locations are shown in Appendix B. The investigation involved soil, soil gas, and groundwater sampling at selected areas. The 2009 investigation found contamination at all 12 sites and ranked Eclipse Electric and Bryant Graphics as prime sources for PCE contamination. The 2009 report also mentions a CVOC source upgradient (west) of Pampered Pooch (7020 Walker St.) and Family Digest (7008 Walker St.). Samples collected at MinValco (3340 Gorham Ave.) had high concentrations of naphthalene, which is very likely related to the Reilly Tar Superfund Site.

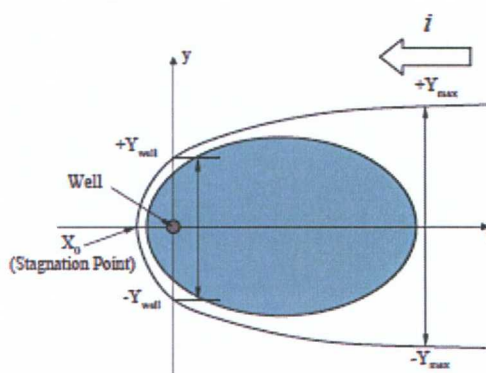
(Figure 14; EPA, 2008)

As noted in Section 3.3 of GHD's Technical Assessment report, both pumping wells capture CVOCs. Given their proximity (hydraulically upgradient) and distance (> 1,000 feet) from 6714 Walker St., these wells are very unlikely to capture groundwater from 6714 Walker St. By applying standard analytical analyses (EPA, 2008.¹²) and published hydraulic values for this area (Lindgren, 1995).¹³, the maximum capture width developed for each well should range between 200 and 800 feet.

Therefore, the Reilly Tar source control pumping wells do not capture CVOC groundwater from 6714 Walker Street, but rather capture CVOCs from an upgradient source close to Reilly Tar. Hydraulic capture zone analysis is presented in Appendix C.

Capture Zone Calculations	W420	W421
Stagnation Point, X_0 [ft]	-123	-34
Maximum Half-Width, Y_{\max} [ft]	385	107
Half-Width at Well Y_{well} [ft]	193	53
Maximum Capture Zone Width [ft]	770	214
